Chesapeake Bay marina builds stronger after snowy collapse

by Anna Townshend

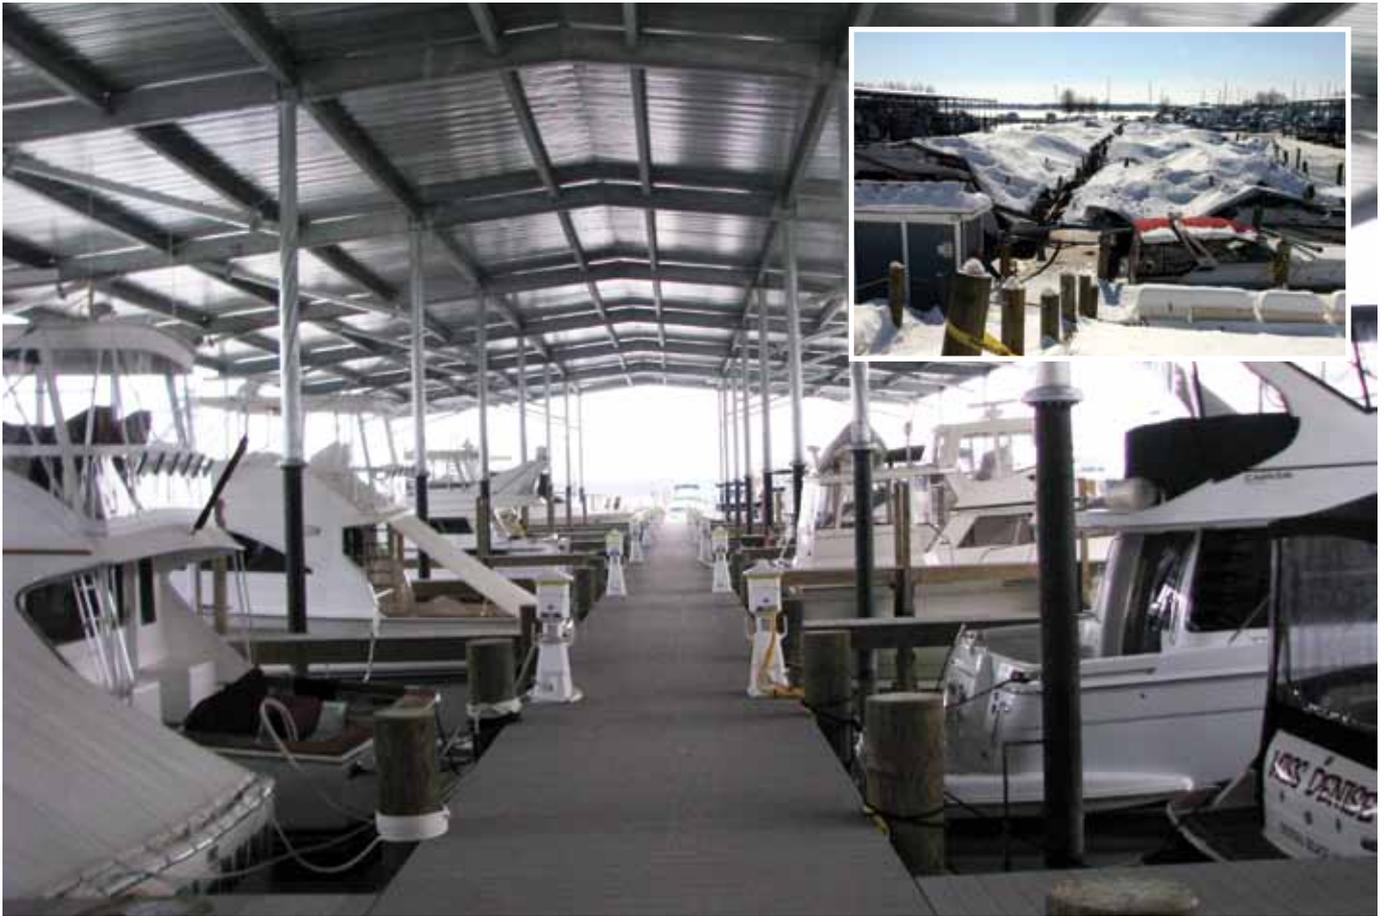
The marina rebuilt its covered docks with a steel-on-steel structure. Twenty-two boats sank to the bottom under the weight of the timber and steel roof wreckage at Bohemia Bay Yacht Harbour in Chesapeake City, Md. Property damage losses were estimated at more than \$2 million on one dock alone. Boat losses were estimated at more than \$4 million.
